Interim Findings from the Hydrologic Monitoring Program

The objective of the CCRN hydrologic monitoring program is to quantify and continuously improve the design and effectiveness of CCRN aquifer recharge projects, and to address legal and regulatory compliance.

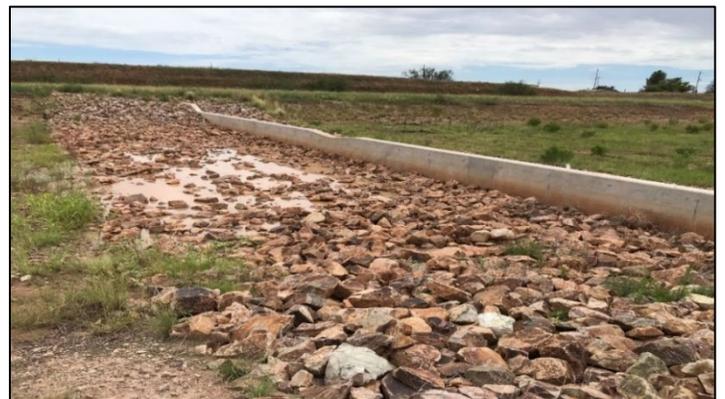
The Palominas Flood Control and Recharge Project collects stormwater from the watershed and infiltrates it into the ground.

The Palominas Flood Control and Recharge Project was constructed by Cochise County in 2014, with the aim of collecting and conveying sheetflow to a constructed channel that had various types of infrastructure to enhance the infiltration of the water into the soil profile for aquifer recharge. Hydrologic monitoring equipment was installed to compare the performance of simple basins to single chamber and double chamber dry wells, and gravel infiltration trenches. A primary purpose of this project was to serve as a testing site for methods to enhance

infiltration of stormwater, serving to inform the design at future CCRN projects. The table below summarizes some of the trade-offs between these different types of infrastructure that have been observed so far.
